NATIONAL TRANSPORTATION SAFETY BOARD

UAS Aerial Imagery Report

A. ACCIDENT CEN20MA044

Location: Lafayette, LA.
Date: Dec 28, 2019
Time: 0921 Central Standard Time (CST)
Event: N42CV PA31T accident

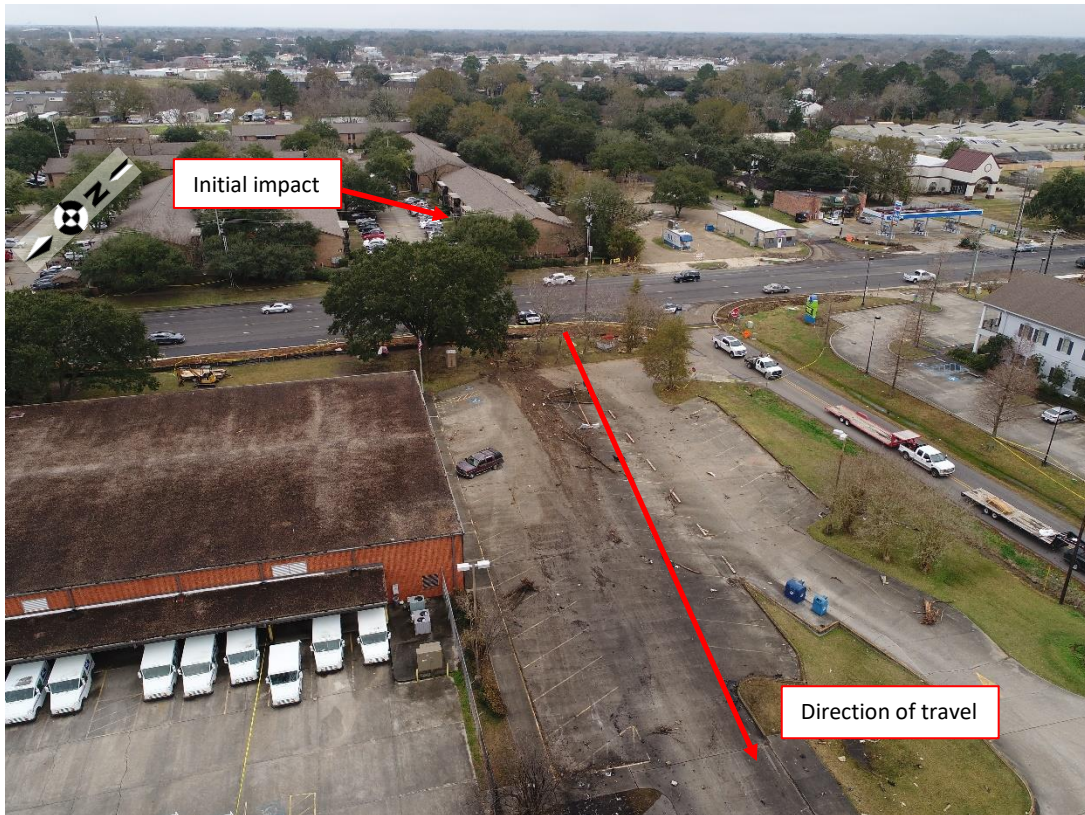
Figures 1 and 2 are overview photos of the impact area and wreckage path. Significant points and directions, determined from the orthomap, are indicated on the photos.

Figure 1 – Overview looking back toward initial impact point

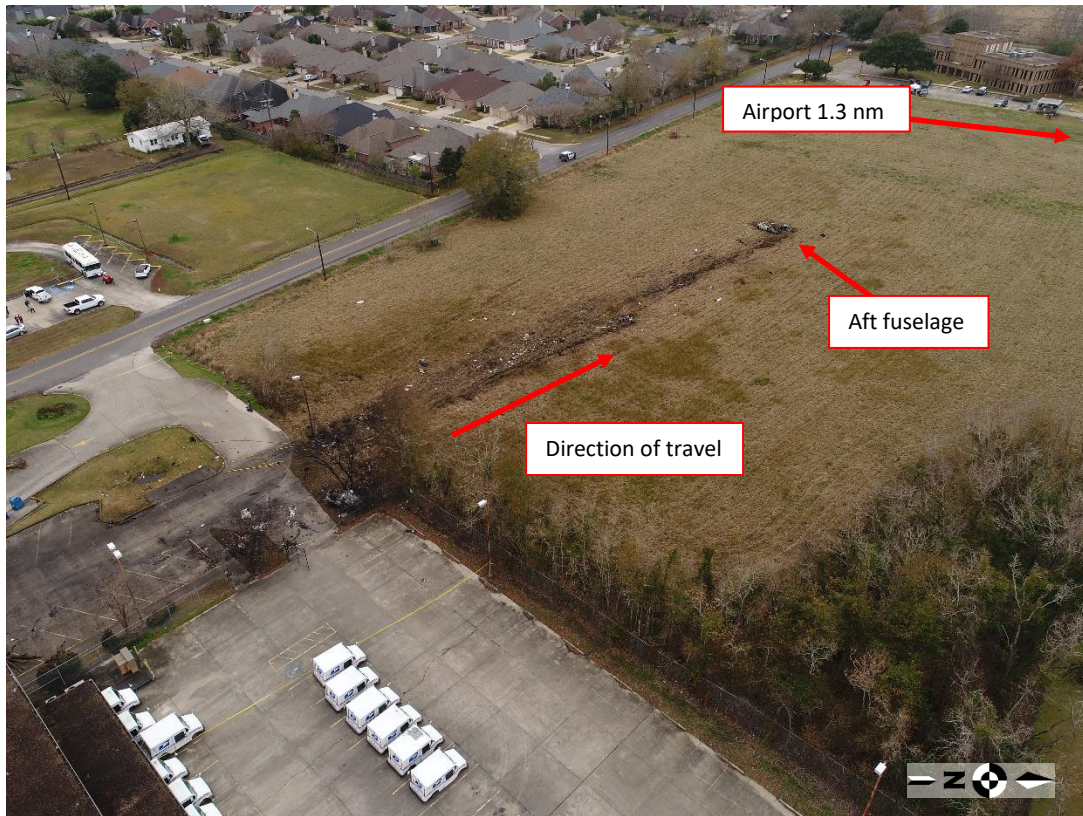
Figure 2 – View from over the post office looking west.

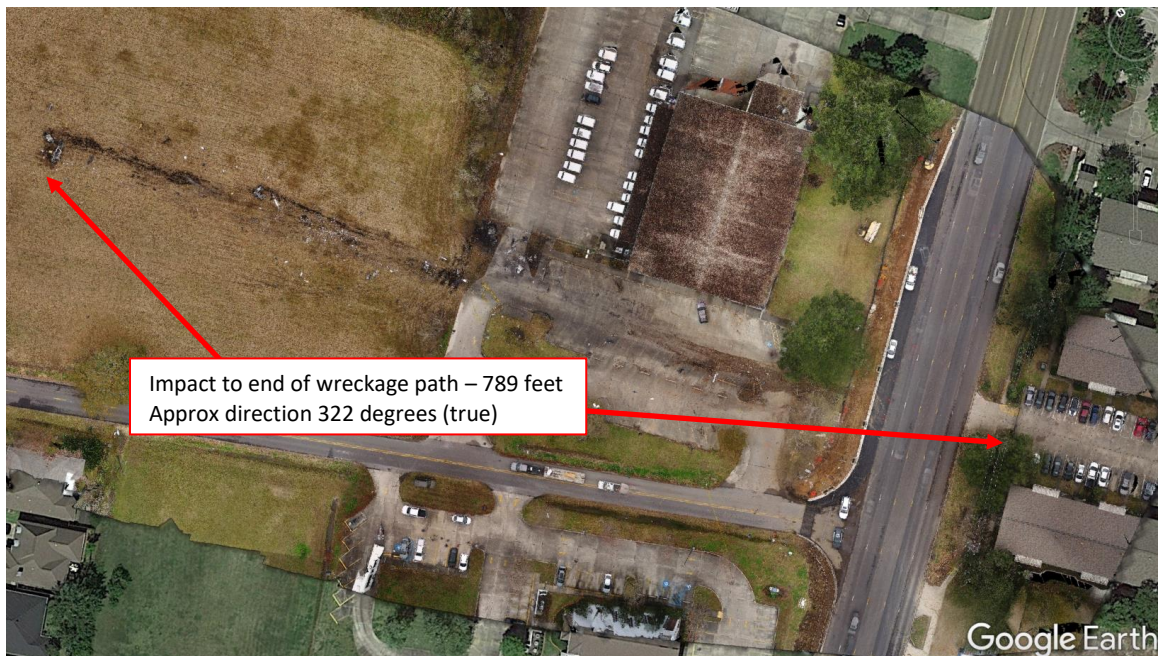
Figure 3 is an excerpt of the Google Earth orthomosaic with select measurements overlaid.

Figure 3 – Google Earth orthomosaic overall

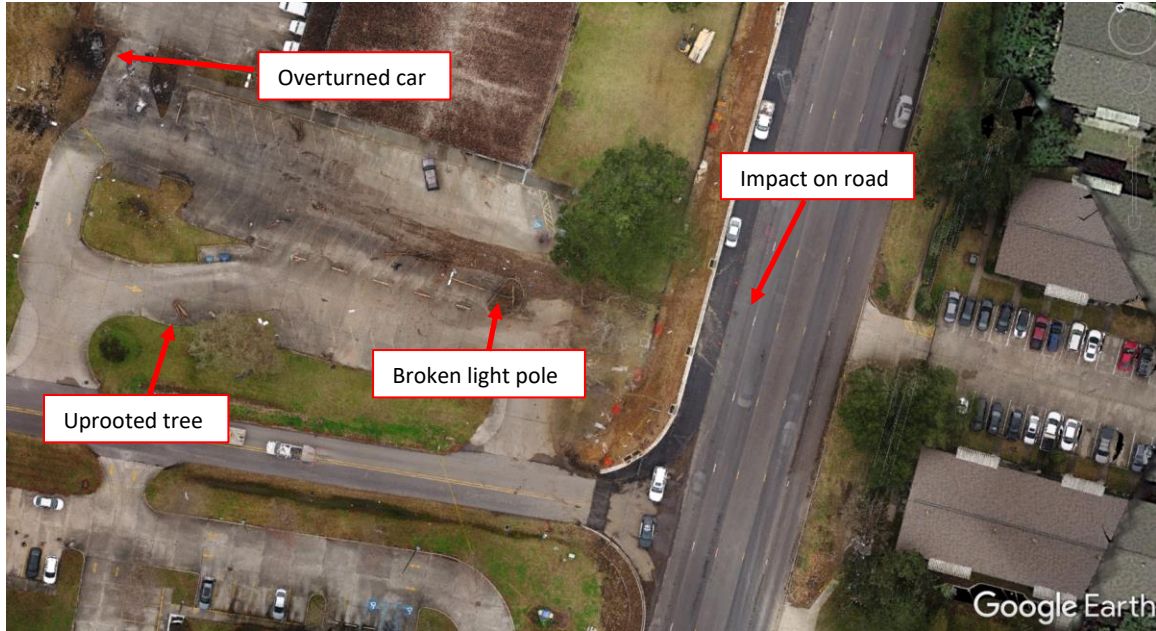
Figure 4 is a view of the eastern portion of the orthomosaic with significant items labeled.

Figure 4 – Eastern portion of orthomosaic.

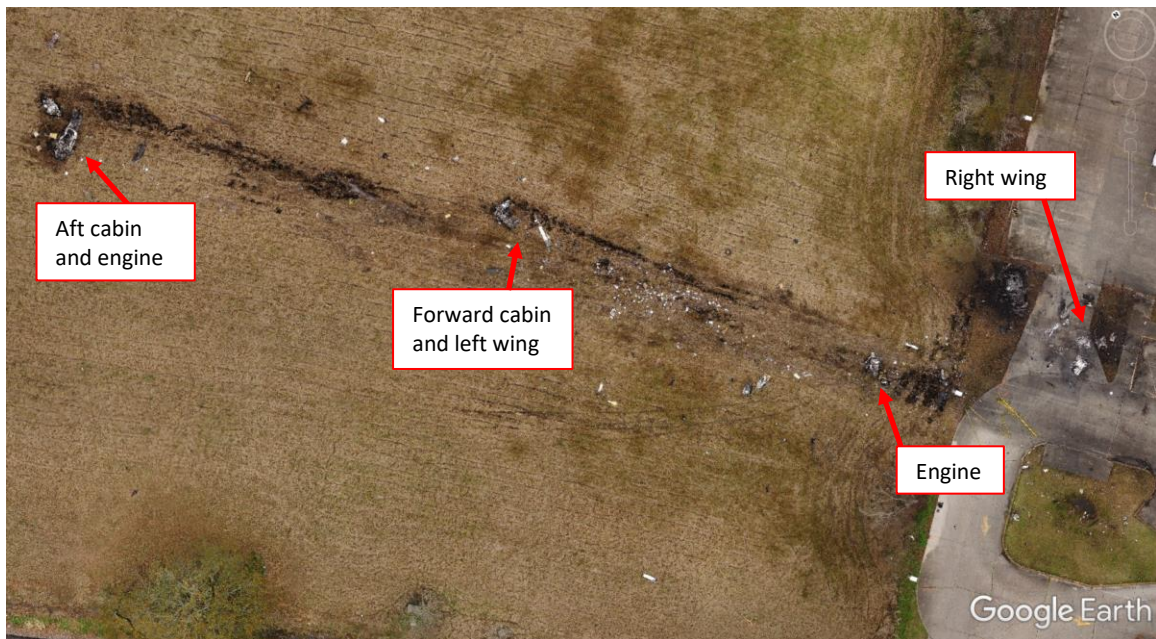
Figure 5 is the western portion of the orthomosaic with select items labeled.

Figure 5 – Western portion of orthomosaic

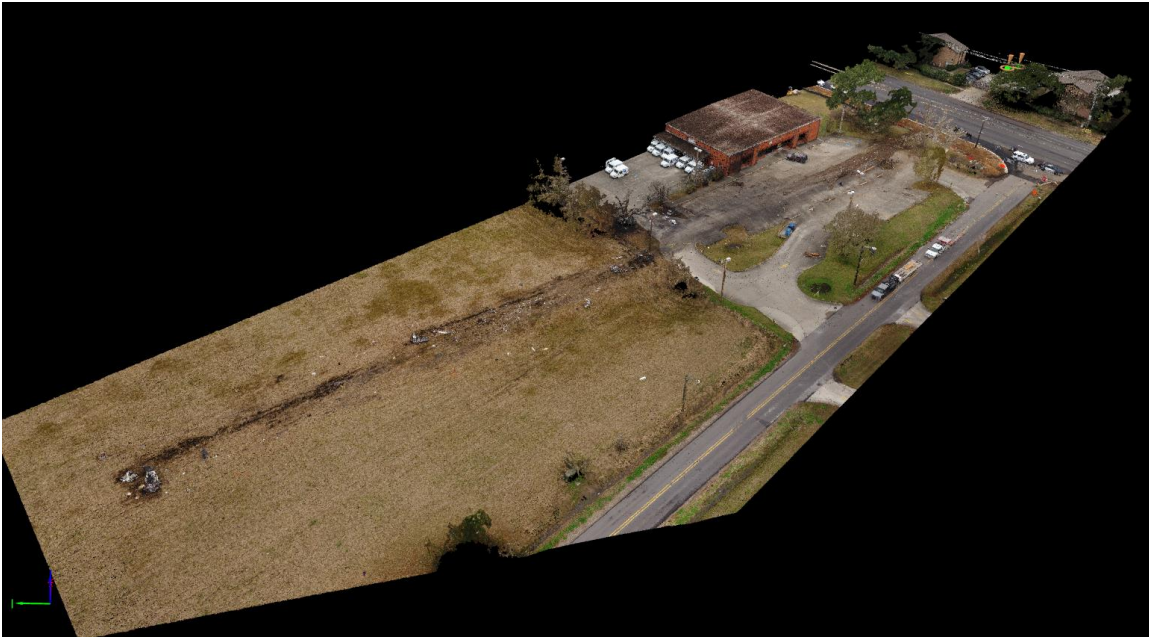
Figure 6 is an oblique view of the 3D point cloud looking to the east-northeast.

Figure 6 – Overall 3D point cloud

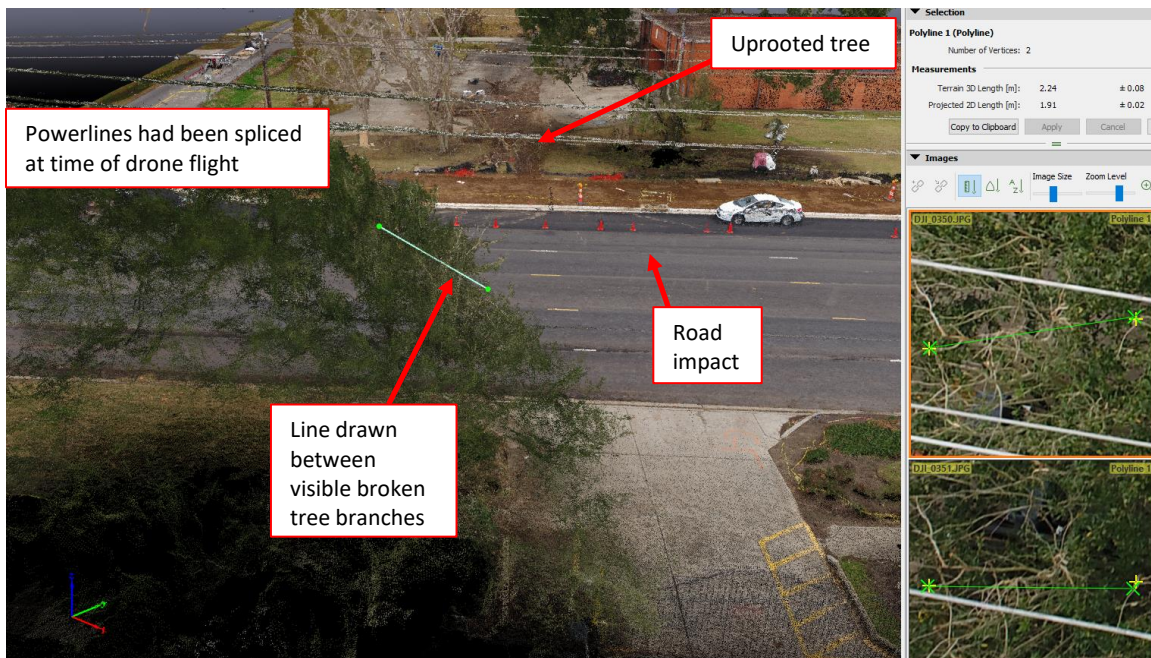
An estimation of a 31.8 degree angle between tree strike marks at the impact point, directly below the powerlines, was made by drawing a polyline between broken branch marks, and solving for the resultant right triangle. (Distance between points $D = 2.24\text{m}$, height difference $H = 1.18\text{m}$; $\arcsin H/D = 31.8\text{deg}$)

Figure 7 – Estimated angle of tree strike

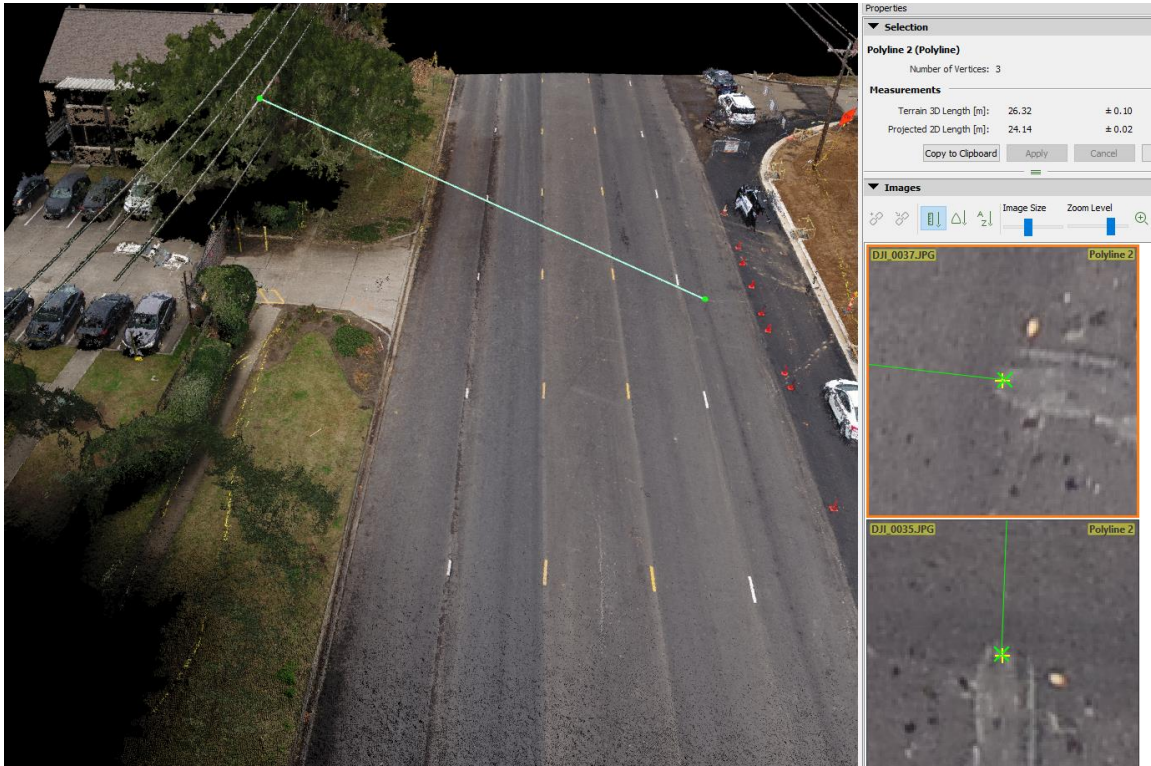
Using the same process as above, the angle from the uppermost powerline, to the impact mark in the road, was calculated as 23.5 degrees.

Figure 8 – Angle from powerlines to road impact
